# **Gamma Count Rate Survey in Pines, Indiana**

**Conducted October 10 – 15, 2009**

**PINES**

**October 27, 2009**

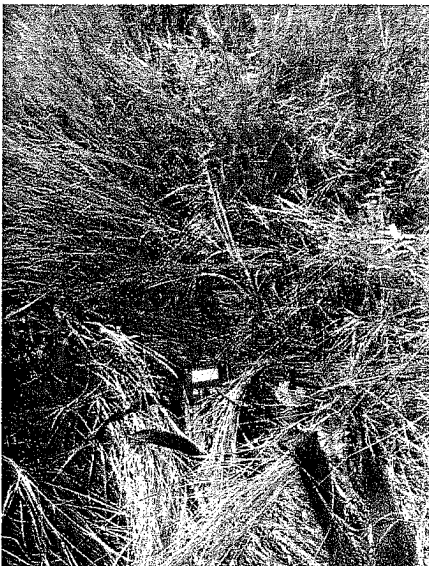
**In weeds to west of Carolina and south of Calumet Bike Trail**

Background Site

Approximately 50 feet southwest of Carolina Avenue and the Calumet Bike Trail intersection

Measurement in grassy area

2 minute count with probe tip on contact with the ground

9743 counts/2 minutes = 4872 cpm

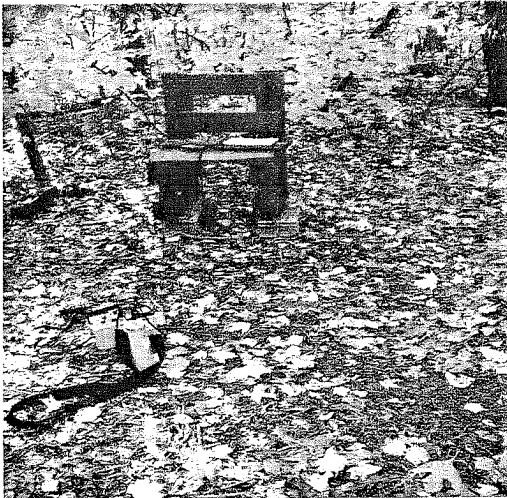
Approximately 100 yards southwest of Islamic Center of Michigan City, in woods  
2 minute count with probe tip on contact with the ground  
 $9670 \text{ counts} / 2 \text{ minutes} = 4835 \text{ counts per minute (cpm)}$

**Background Site: Approximately 100  
Yards southwest of Islamic Center]  
Of Michigan City. in woods**

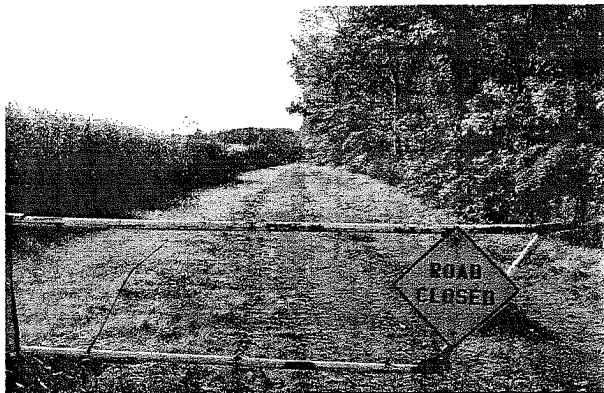
East gate at **Exemption 6**

- \*\* West of gate near County Line Road  
Glittering black material on surface  
9500 – 10,000 counts per minute (cpm)
- \*\* Approximately 200 feet north of 1600 N in wooded area  
approximately 9000 cpm
- \*\* 2 minute count with probe tip on contact with the ground  
21,387 counts/2 minutes = 10,694 cpm
- \*\* At farmer's vehicle entrance to field, on north side  
approximately 9000 cpm

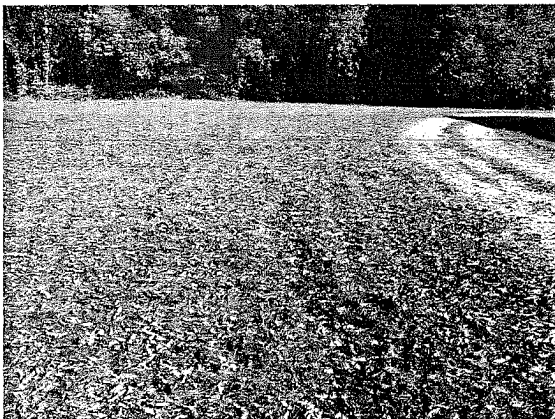
- \*\* Paved parking lot  
Approximately 7000 counts per minute (cpm)
- \*\* South side, grassy area  
7000 – 8000 cpm
- \*\* Gravel drive on south side  
3000 – 3500 cpm

- \*\* West side, grassy area towards the south end  
3500 – 5000 cpm
- \*\* West side, grassy area towards the near north side / tree line  
8000 – 8500 cpm

- \*\* North side, grassy area  
4500 – 5000 cpm
- \*\* Far east side in grassy area  
4000 – 5000 cpm
- \*\* Apron of parking lot on east edge – in line with crack running east/west in alignment with north wall of building  
10,000 – 10,500 cpm

- \*\* In limited grassy area in east near Exemption 6  
10,000+ cpm
- \*\* East side, approximately 50' from parking lot edge  
7500 – 8000 cpm  
(appears to be a seam that runs north / south along parking lot edge)  
8500 – 10,000 cpm

Grassy area, south side of mosque

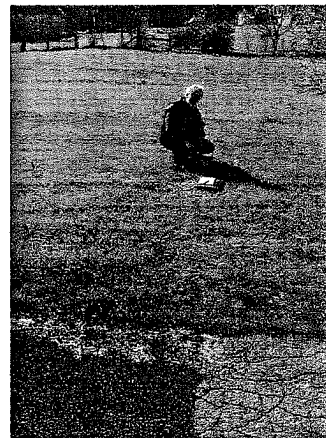
- \*\* South side of drive entrance next to asphalt patch  
about 11,000 cpm  
2 minute count with probe tip on contact with the ground  
21,121 counts / 2 minutes = 10,561 cpm

South of entrance drive patch

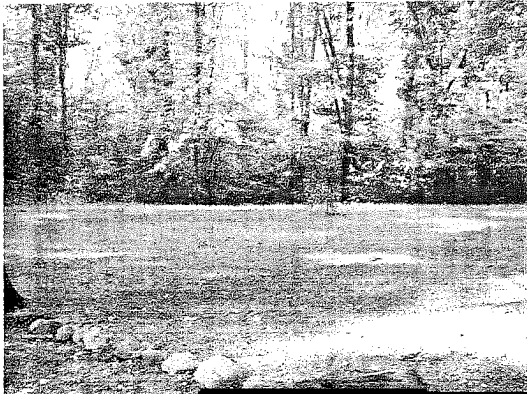
Front yard at **Exemption 6** **Exemption 6**

- \*\* Parking area by tree holding security light  
Approximately 4500 counts per minute (cpm)
- \*\* South side of front yard  
5000 – 6000 cpm

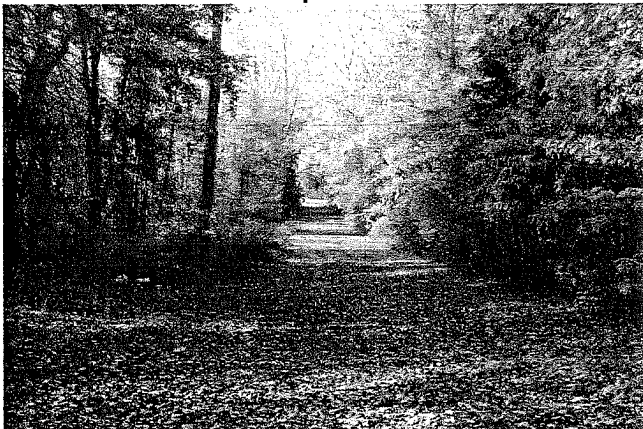
**Connecticut Avenue at 2<sup>nd</sup> Place looking north**

Approximately 2/3 distance north of 2<sup>nd</sup> Place towards Highway 12

- \*\* Center of Connecticut Avenue  
Glittering black material on the avenue  
11,000 – 14,000 cpm
- \*\* Approximately 15 feet east of center of avenue in grassy area  
approximately 12, 000 cpm
- \*\* Approximately 25 feet east of center of avenue in woods  
4500 – 5000 cpm

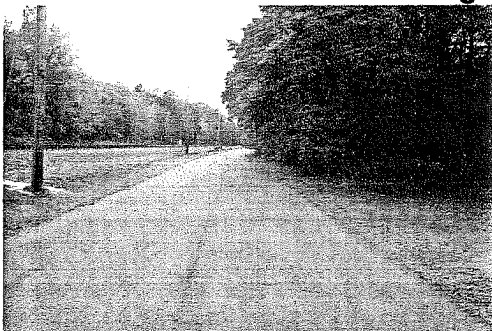
675 Railroad Avenue, north side, on west side of driveway, along berm  
11,000 – 12,000 counts per minute (cpm)

675 Railroad Avenue, north side, to east side of driveway, along berm  
9000 – 11,000 cpm

675 Railroad Avenue on south side of avenue, between avenue and railroad tracks  
8000 – 11,000 cpm

**Railroad Avenue at 675 looking east**

**Railroad Avenue at 675 looking west**

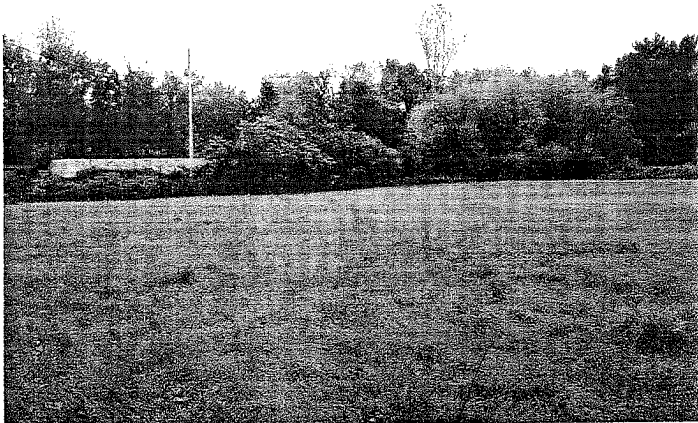
Survey from 650E,  $41^{\circ}40'58''\text{N}$  –  $86^{\circ}56'32''\text{W}$  to 675E,  $41^{\circ}41'06''\text{N}$  –  $86^{\circ}56'15''\text{W}$

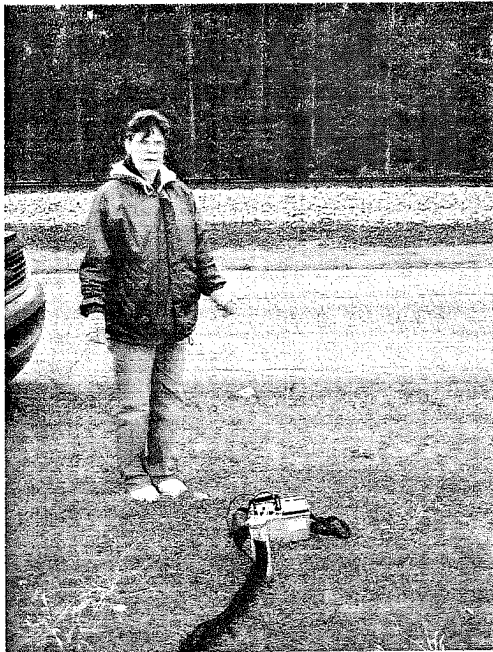
656 Railroad Avenue, north side, walking west on berm to 650 Railroad Avenue  
4500 – 11,000 cpm  
(lowest count rate at large tree on 656 Railroad Avenue)

Between 650 and 656 Railroad Avenue, south side on berm  
6500 – 11,000 cpm

**Railroad Avenue at 656 looking south**

**Railroad Avenue at 656 looking west**

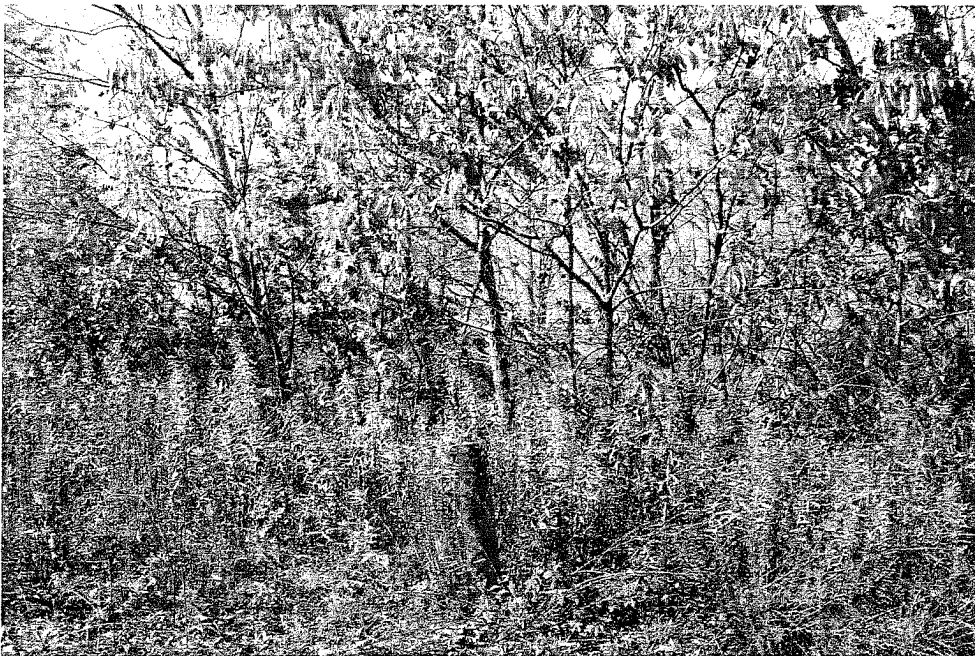
**Monitor well south of Yard 520**

Monitor well on south side of landfill, on Railroad Avenue

- \*\* North side of monitor well  
8500 – 9000 counts per minute (cpm)
- \*\* South side of monitor well  
11,000 – 12,000 cpm  
41°40'323"N – 86°57'38"W

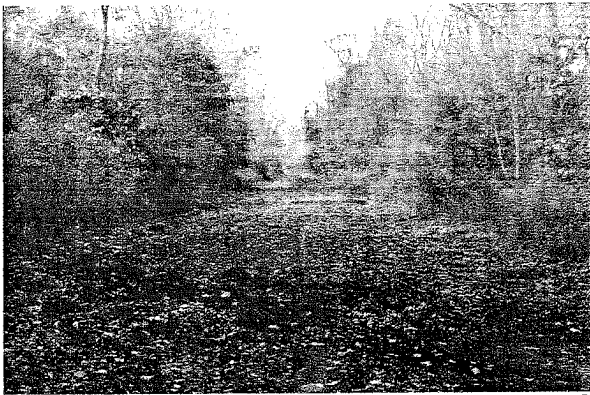
**Illinois Avenue at Railroad Avenue, 41°40'55"N – 86°56'40"W**

Illinois Avenue from Railroad Avenue to Johns Avenue

4500 – 12,000 counts per minute (cpm)

higher count rates where glittering black material was present

\*\* Center of Illinois Avenue, 200 feet north of Railroad Avenue

25,005 counts/2 minutes = 12,503 cpm

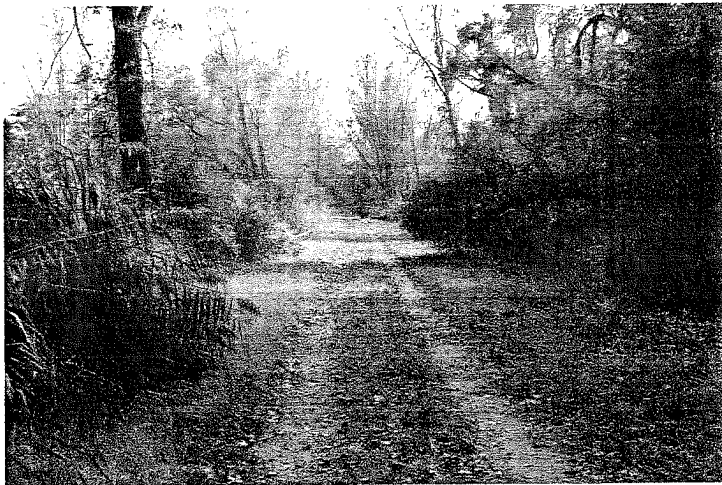
**Illinois Avenue At Johns Place looking south, 41°41'16"N – 86°56'40"W**

lower count rates near Johns Avenue

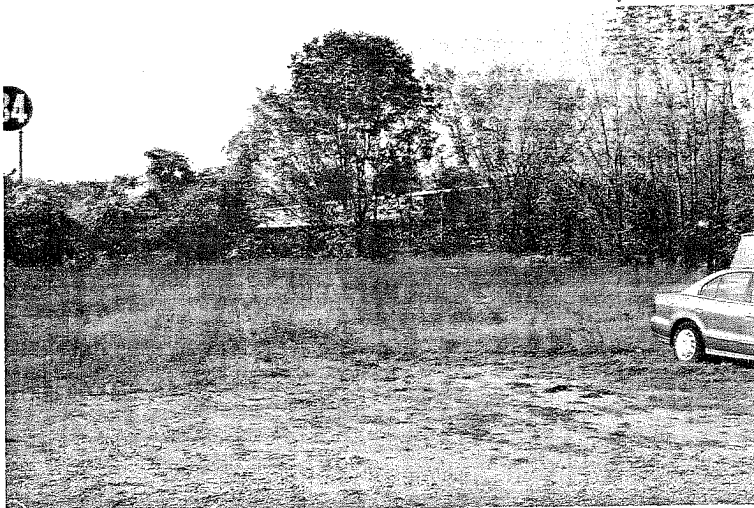
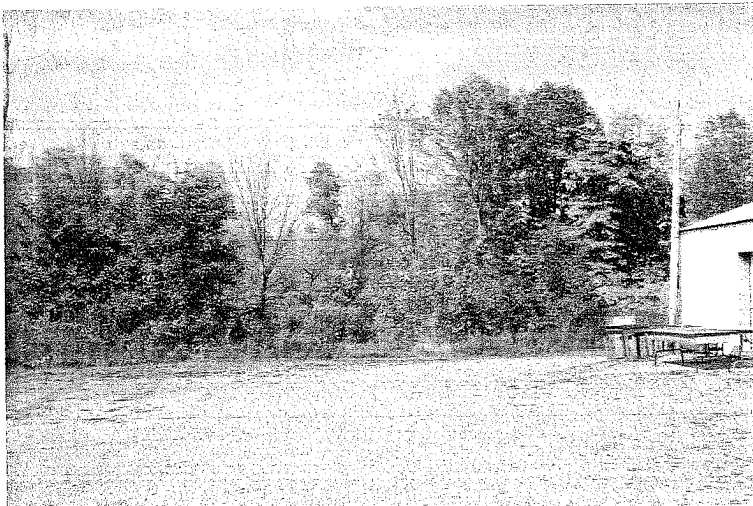
- \*\* Parking lot**  
on "slag" type material  
8000 – 9000 counts per minute (cpm)
  - \*\* Weedy field to west of parking lot**  
7000 – 8000 cpm
  - \*\* Dumping area to north of parking lot**  
7000 – 8000 cpm
  - \*\* Lowland area to north of dumping area and north of parking lot**  
5000 – 6000 cpm
- 41°40'51"N – 86°56'20"W**

**At SS018 field looking west**

**At SS018 woods looking north**

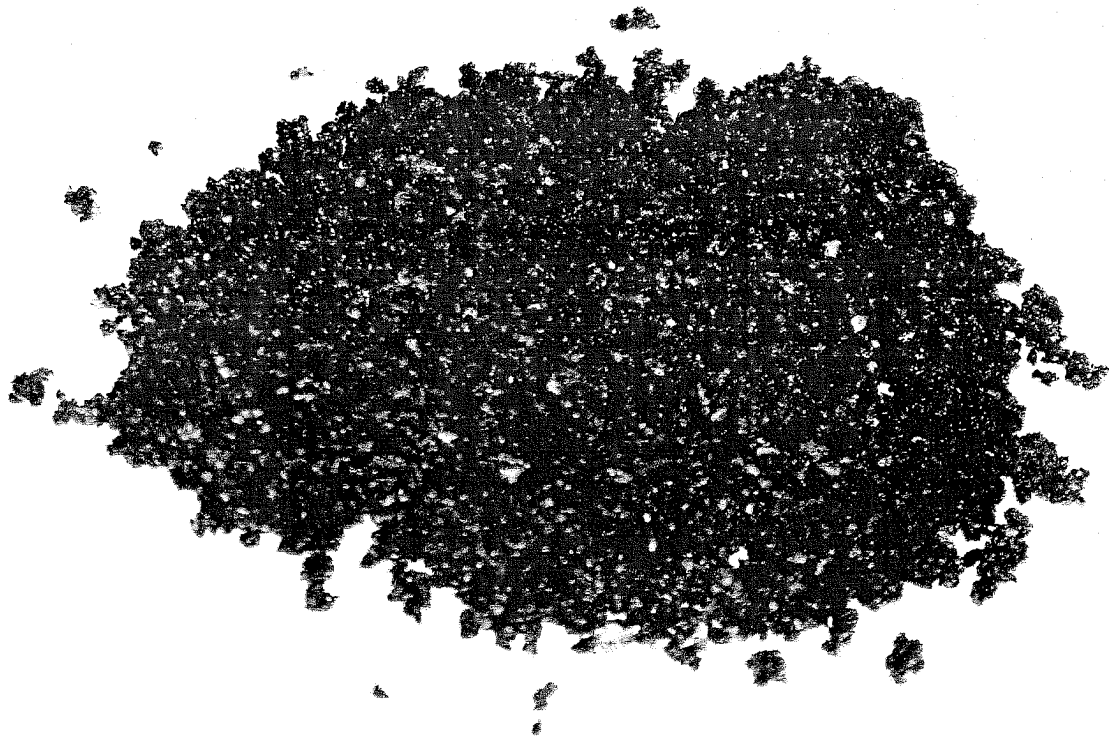
## **Black, Glittery Material**

In almost every case, excess count rates were associated with a black, glittering material. PINES surveyors called this material flyash. The survey leader was more familiar with material of this appearance being called sand blasting grit. The most elevated gamma-ray count rates were all associated with roadways and the berms adjacent to them.

Where readings were elevated, the area was usually covered with a black, glittery material with the appearance of finely ground obsidian. Surveyors called this material flyash. The health physicist operating the meter had seen similar material used for sandblasting.

Determination be made as to the component giving elevated gamma-ray count rates (e.g., black glittery material?).
